The restoration and the anastylosis of the Macedonian tomb of “Macridy Bey” near Thessaloniki

Fani Athanassiou, Venetia Málama, Maria Miza, Maria Sarantidou, Alexios Papasotiriou

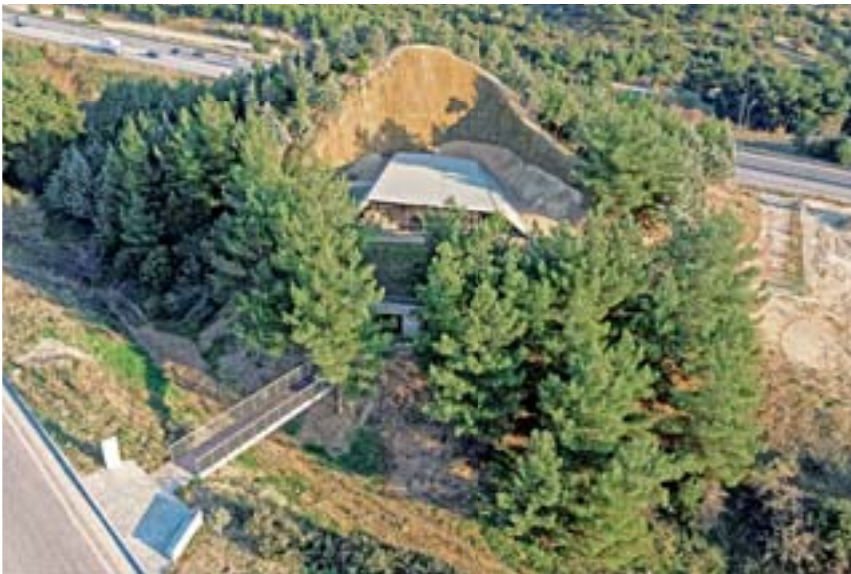
2/ Macedonian tomb of "Macridy Bey", the archaeological site post-intervention (2015).

To guarantee the physical integrity of the monument (tomb, tumulus, and *dromos*), and in particular to remove the causes which led to the structure's complex pathology, it was considered imperative to provide it with a protective covering which, in combination with the waterproofing of the surrounding ground, would ensure the appropriate microclimatic conditions for its hygrothermal (moisture/temperature) protection⁴² (figs. 2-3).

The entrance to shelter B on its west side is configured as an antechamber with rectangular ground plan (fig. 2). The roof of the antechamber comprises a continuation of the inclined section of the shelter, and is also planted. The entrance door occupies the greater part of the façade and is perforated to permit air to circulate freely and offer a view of the monument at night.

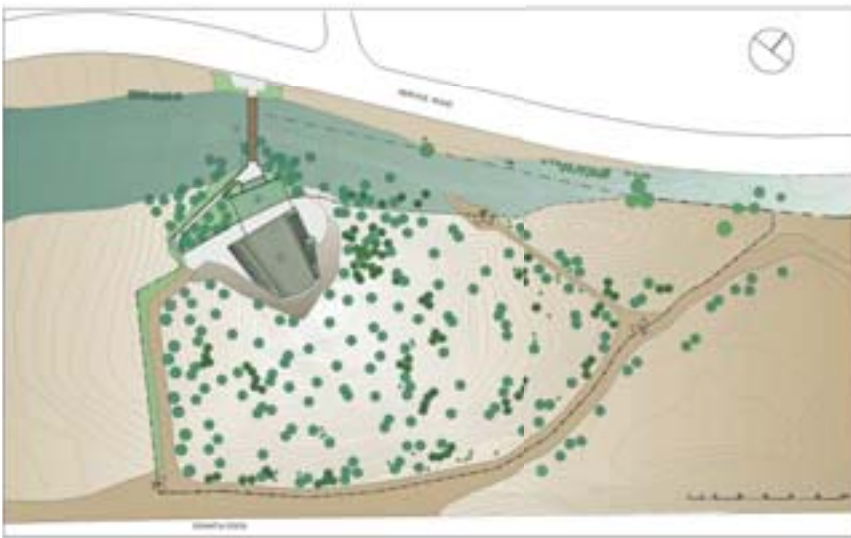
3/ Macedonian tomb of "Macridy Bey", site plan, post - intervention.

The tomb is set off-center on the west side of the tumulus and belongs to the two-chambered type of Macedonian tomb⁷ (fig. 3). The antechamber and burial chamber, which have different dimensions (fig. 4), are built of brown or grey limestone ashlar of varying sizes⁸.

Shelter B is undercut and consists of one level and one inclined section with a surface area of 134 m² (fig. 3). Its level section was designed to be walkable, thus allowing visitors to circulate at the level of shelter A and view the monument from its west main face. The goal of the morphological design of the inclined section was to restore the original form of the slope of the tumulus. Towards this end, it was designed with a pronounced slope of 46%.

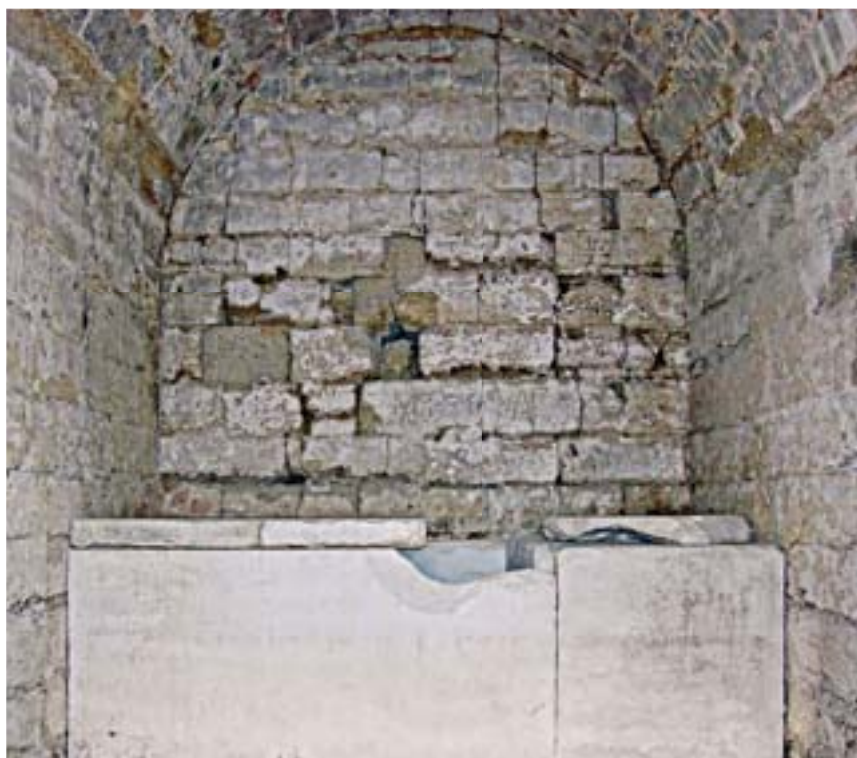
On the east side of the burial chamber there is a marble burial construction (height 1.32 m.) resting on the ground (fig. 6). On its interior, the construction is divided into two spaces of unequal size, a sarcophagus and a container (fig. 4, plan). Beneath the sarcophagus floor is a cist grave of porous stone coated in mortar (fig. 4, section). An oak *larnax* (cinerary urn) was set inside the tomb¹³. The cist grave was covered with porous stone slabs which formed the floor of the sarcophagus. The container and

6/ Macedonian tomb of "Macridy Bey", the marble burial construction (the sarcophagus and the container) after the conservation work and lighting.

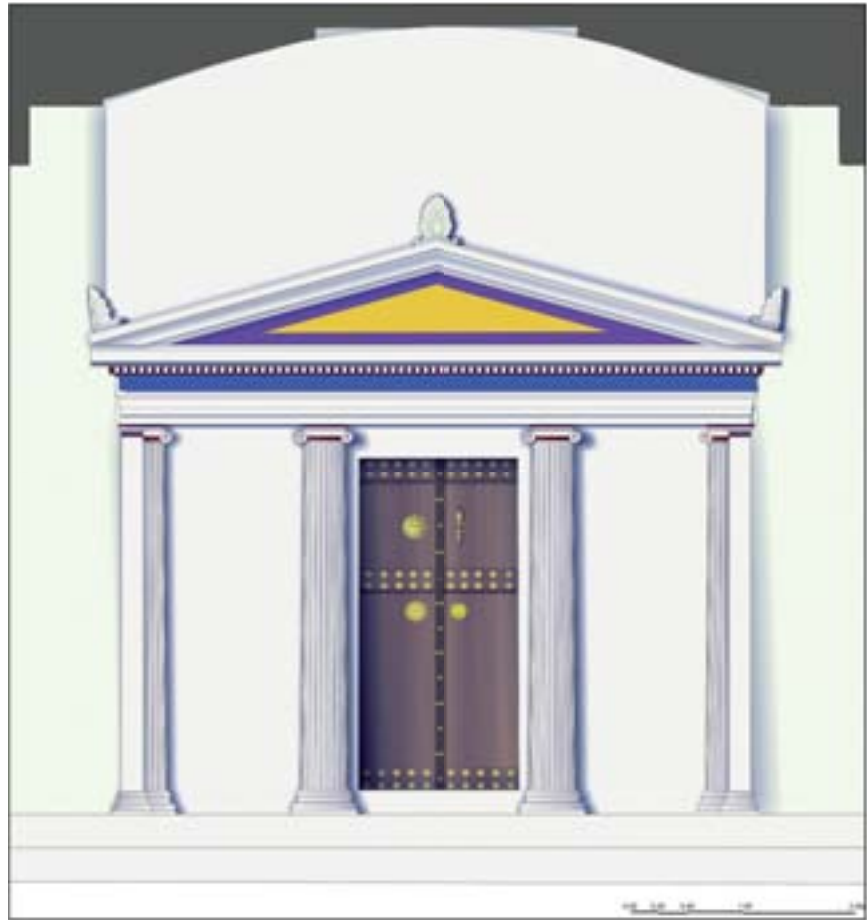
8/ Macedonian tomb of "Macridy Bey",
graphical reconstruction of the
antechamber west wall.

The front of the tomb was painted. During the 1910 excavations, traces of red and blue were found on the column capitals, the epistyle and the cornice, while a bright yellow color surrounded by violet was discovered on the drum of the pediment²². The semi-columns, quarter-columns, pilasters, and blocks of the façade were coated with a white mortar which remains preserved²³ (fig. 8).

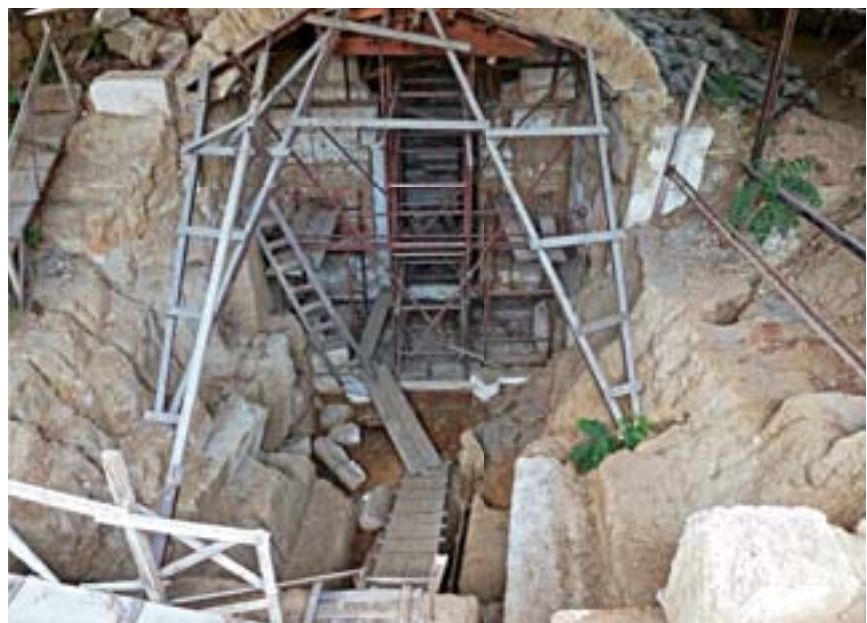
14/ Macedonian tomb of "Macridy Bey", state of conservation.

The greatest deformation was observed in the building's vaults, chiefly that of the antechamber, which was already on the verge of collapse (fig. 15). Specifically, the burial chamber's vault had decreased in height by 0.22 m, and that of the antechamber by 0.43 m. As a consequence, a dense web of cracks (width up to 0.10 m) pervaded the vaults. In 2011 before the start of work, the antechamber vault exceeded the limits of stability, and rested permanently on the scaffolding used to shore it up (fig. 14).

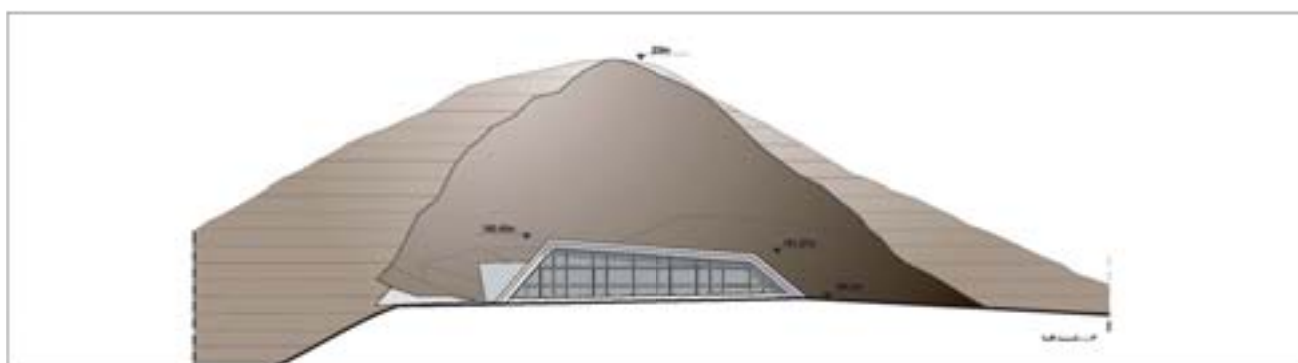
18/ Macedonian tomb of "Macridy Bey", protection of tomb and dromos, the shelters.

study, namely: its form was to be such as not to compete with the monument, and to be integrated into the landscape as shaped by the 1990s excavation without disturbing it. These choices led to the designing of a shelter that was trapezoidal in both plan and cross section (figs. 1,18). The shelter's plan was adapted to the perimeter of the toe of the mound's vertical excavation face, while its trapezoidal section recalls the outline of the face of the mound's excavated section on which the shelter is projected. The shelter's main western face is perforated, thus permitting the monument to be viewed from the level of the upper story. The north and south faces are configured with frames of metal blinds enclosed by sections of sheet metal⁴⁴ (fig. 19). The entrance, located on its north face, is configured as a covered antechamber which projects from the face and leads to the level of the vault of the building (fig. 18).

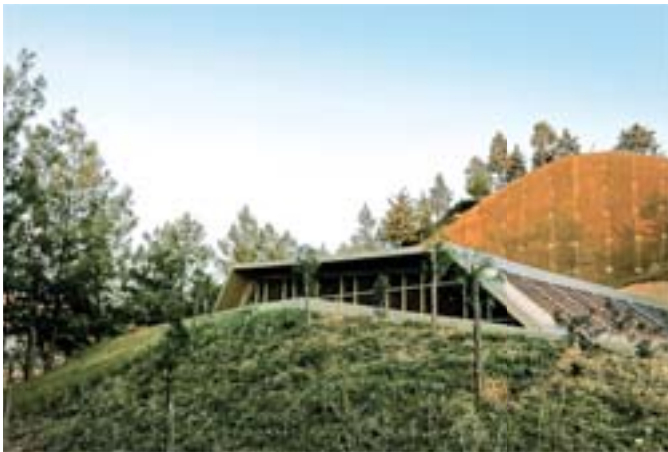
19/ Macedonian tomb of “Macridy Bey”, protection of the tomb and dromos with new shelters.

For reasons of thermal insulation and integration into the natural environment, the shelter's roof was planted with low-intensity growth of a spreading type similar to that which grows in the natural environment (fig. 19).

Protecting the vertical face of the tumulus from erosion and improving its stability were achieved by covering its surface with a geo-synthetic mesh (fig. 19) which was stabilized with wire ropes and bonded anchors (soil nailing)⁴⁵. At the toe of the vertical face of the excavation, the accumulated erosion deposits were covered with a layer of stabilized earth, and they are used as a counterweight, reinforcing the stability of the excavation face (fig. 2).

Plantings had a functional, ornamental or occasionally, protective character⁶⁶. To integrate it into the natural environment, the inclined roof of the protective shelter of the ancient *dromos* was planted with low-requirement, spreading plants similar to the native flora (fig. 19). Planting was extended on either side of the roof of shelter B with the goal of fully incorporating it into the environment while simultaneously protecting the slopes of the tumulus from erosion.

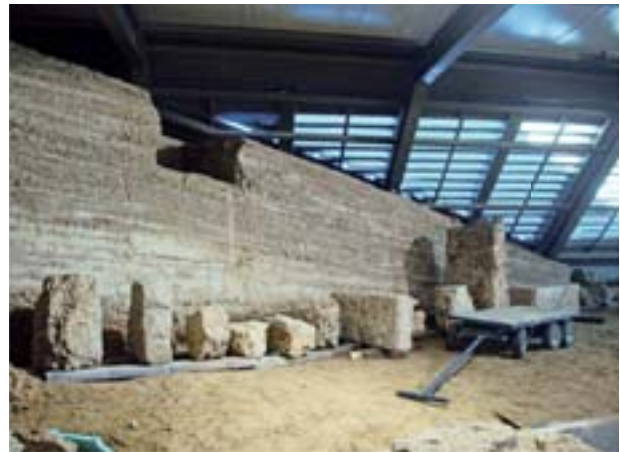
20/ Macedonian tomb of “Macridy Bey”, shelter rammed earth foundation.

To avoid disturbing the stratigraphy of the tumulus, the shelter has a shallow foundation. It consists of two strip footings constructed along the shelter's north and south sides, resting at the level of excavation of the tumulus during the 1990s. The foundation of the east side is different. There, to avoid constructing a reinforced concrete wall, a special geo-construction (reinforced and stabilized fill) was employed as a sort of gravity-retaining wall on which the shelter's bearing organism was set (fig. 20).

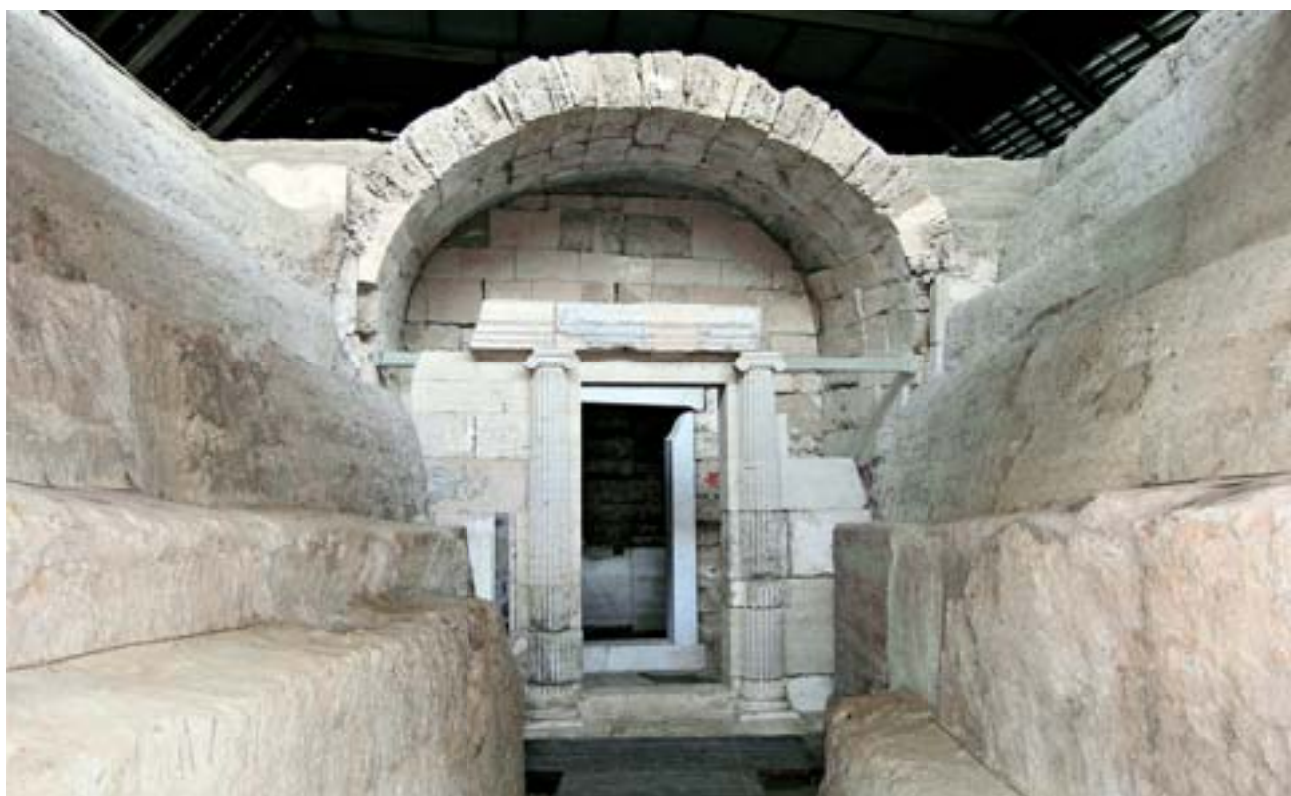
23/ Macedonian tomb of “Macridy Bey”, longitudinal section, structural restoration of the antechamber side walls, structural reinforcement.

The goal of the intervention was to restore the stability and structural integrity of the tomb in its deformed state, without altering its dry construction. The basic choice of the study was to remediate the building's dilapidated state, above all its vault and antechamber, without dismantling it⁴⁹. For this purpose, a complex technique of stitching and grouting the cracked voussoirs⁵⁰ and ashlar of the antechamber's long walls *in situ*⁵¹ was studied and implemented, using a specially-developed injection grout⁵² which allowed for their structural separation even after intervention (figs. 23-24). The cracks in the voussoirs as well as the enlargements of the contact joints between courses in the gaps in the joints of the vaults were not filled with mortar in order to avoid altering the structure's dry construction method and modifying the image of the monument as it had been preserved down through time⁵³ (fig. 25). Interventions to the ashlar of the antechamber walls were limited solely to those positions where the type of damage threatened the stability of the construction, that is, to the crowning (upper edges) of the long walls. The restoration of the destroyed surfaces of the ashlar was done with a specially-designed compatible mortar of similar color and shade, and in accordance with the geometry of the deformed form of each individual ashlar (fig. 26).

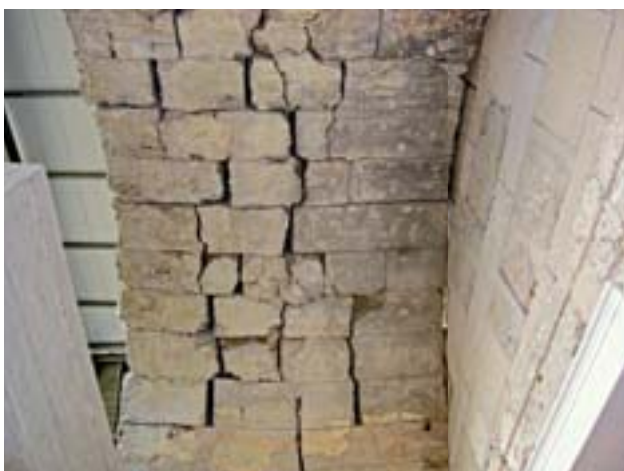
27/ Macedonian tomb of "Macridy Bey",
anastylosis of antechamber west wall
(façade), structural reinforcement,
support beam.

To avoid the risk of the wall's tilting⁵⁵, a stainless steel beam was incorporate in the rebuilt ashlar of the eighth course to provide lateral support (figs. 21-22, 29). The beam transfers the loads from the façade to the lateral walls of the antechamber at the height of the tenth course. At this height there are carved notches by which the architrave was connected to the side walls. The beam is supported with bonded anchors embedded in
